Highlights of the Uganda Atlas of Our Changing Environment

KAMPALA'S CHANGING ENVIRONMENT

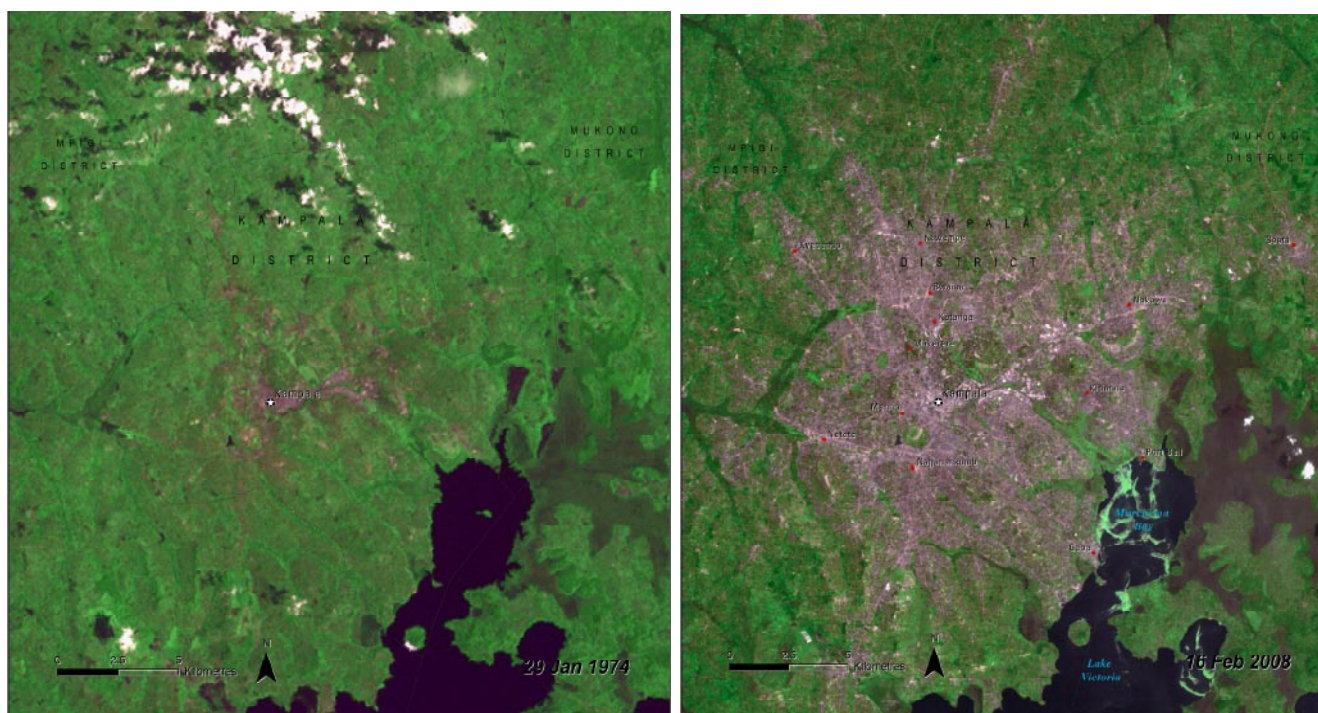
Figure 2: Expansion of Kampala City from 1973 to 2008. The waters of Lake Victoria at the Murchison Bay in Luzira were clear in 1973. By 2008 a green substance covers the bay at the mouth of Nakivubo Channel.

The waste water from the city flows into the lake through the Nakivubo Channel, which was built to stop the lower areas of the capital from flooding. Overtime the water in the Lake Victoria has become more turbid and this has a negative impact on the fish industry since it leads to silting up of the breeding grounds for fish. A thick carpet of algae has covered Lake Victoria's Murchison Bay, causing a sickening stench in Luzira, Ggaba and Munyonyo. The algae mass, which looks like green oil paint on the lake surface, is a result of increased pollution from human disposal and industrial waste.

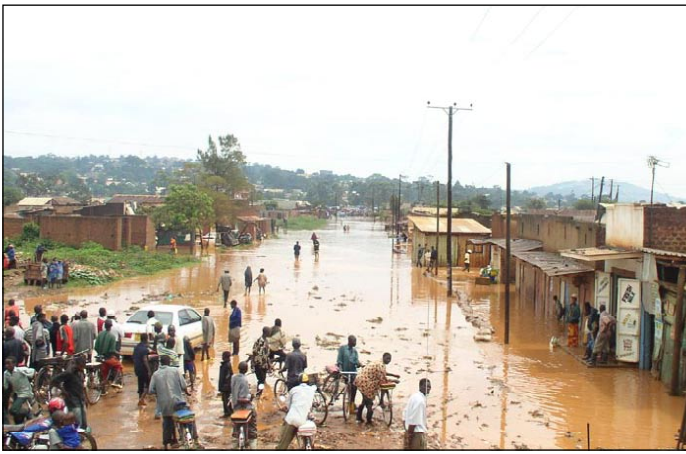
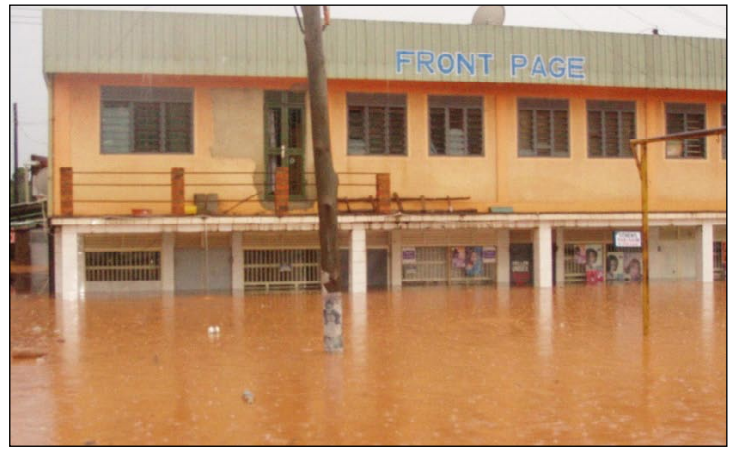
Figure 3: Unplanned settlements in a wetland in Bwaise blocking the waterways and causing floods (2007). Construction of structures in drainage channels at Zana on Kampala-Entebbe highway resulted in flooding in 2007.

Kampala is served by two major wetland systems; namely the Nsooba – Lubigi and Nakivubo Wetland systems. These also act as the main drainage systems out of Kampala. Recent developments have seen the clearing of the buffer zones of forests and open spaces, as well as encroachment on the wetlands in favour of unplanned settlements. Most of Kampala's land surface in the built up areas is highly paved leading to reduced water infiltration which leads to generation of high storm waters. Of late storm water causes flooding in some places such as Bwaise, Kalerwe, Clock Tower and Kyambogo.

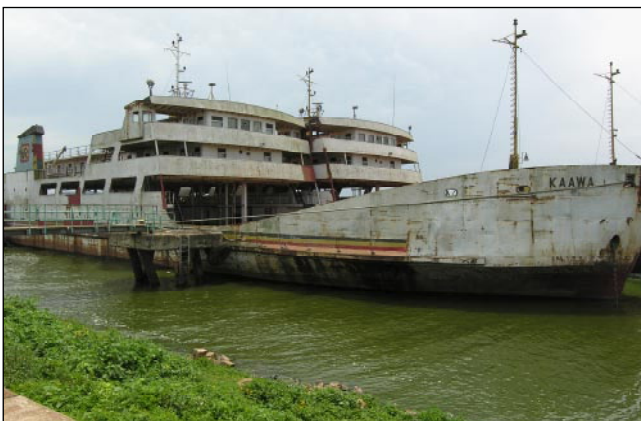
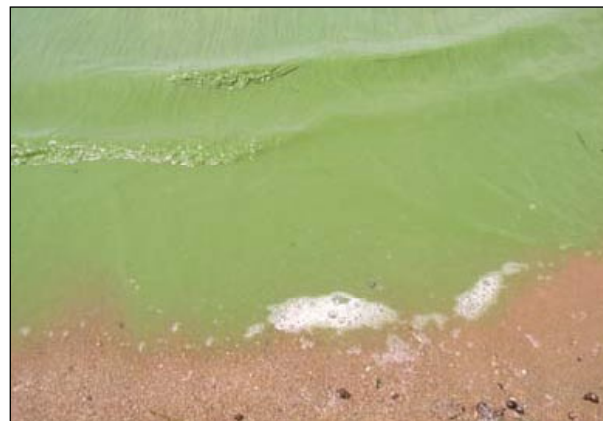
Figure 4: Water is green and smelly at Port Bell, Luzira (2009) and Katosi landing site in Mukono District (2004), left and right respectively.
