Highlights of the Uganda Atlas of Our Changing Environment

POLLUTION OF WATER BODIES

LAKE VICTORIA AND LAKE ALBERT

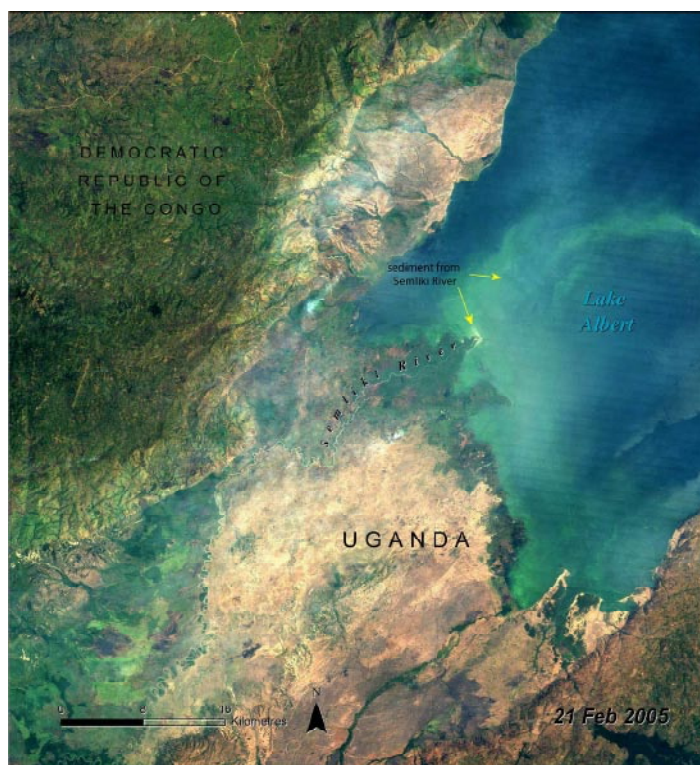
Figure 1: Silt from River Semliki drains into Lake Albert.

River Semliki is one of the most important rivers that form Uganda's natural drainage system found in Bundibugyo District, in the Western Uganda. The river derives its origin from Lake Edward through Mt. Rwenzori, and also through a series of tributaries that join along its 140 km course in the Albertine Rift (Western Rift Valley) before draining into Lake Albert. Over 10m of the river bank on Uganda's territory is eroded annually at various points of the river and as a result, the river seems to have doubled its width within the last ten years. Increased river bank erosion due to overgrazing, melting of ice on the Mount Ruwenzori and degradation of the water catchments has resulted in siltation changing the river course significantly over the years as it enters the Lake Albert (NEMA 2006). The bathymetry of Lake Albert shows that the lake is shallower in the south where the Semliki River drains into the lake.

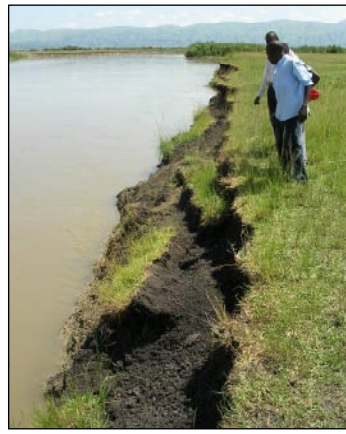
Figure 4: The process of riverbank breakage.

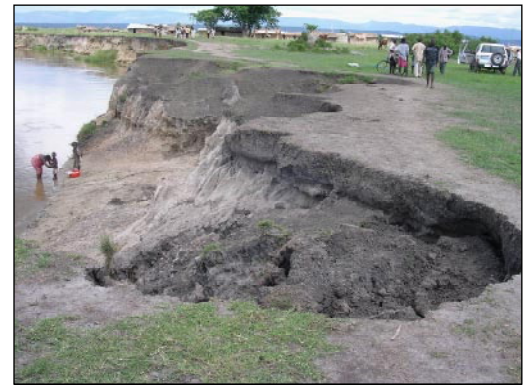
Figure 5: An eroded river bank threatens a village.

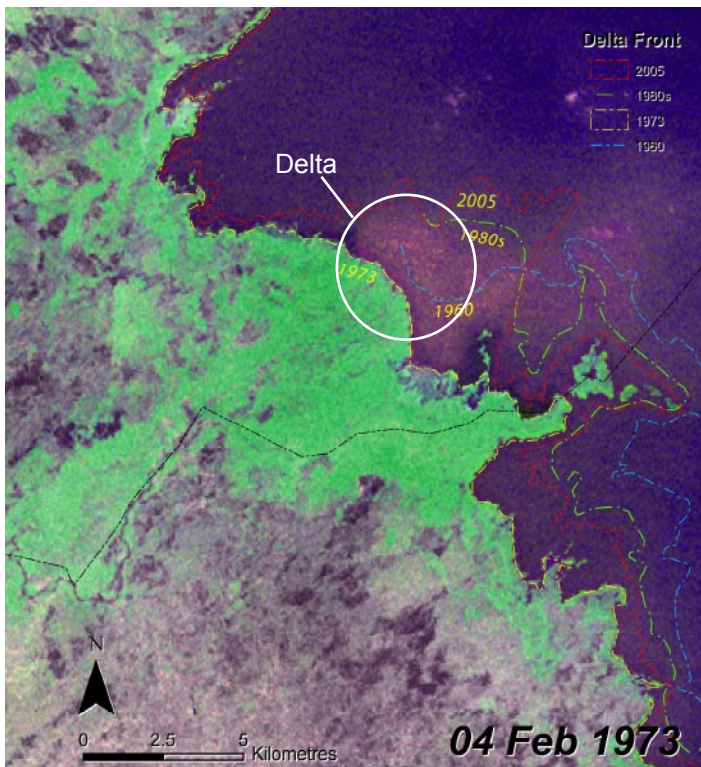
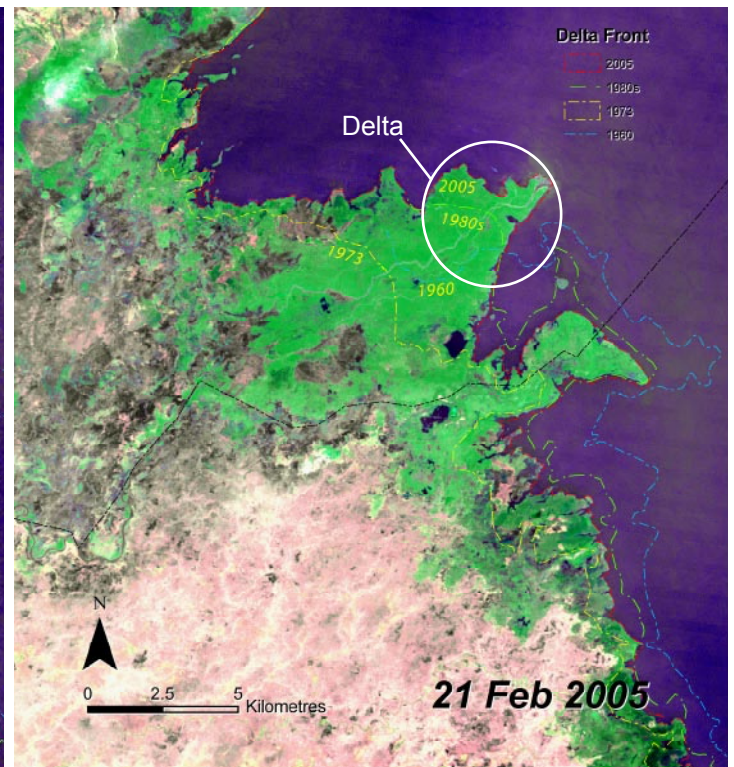
Figure 6: Formation of a delta at the mouth of River Semliki. The delta formed after 1973.

There is evidence from the 1960 topographic maps, spot image of 1980 and Landsat TM image of 2000 that the delta on the southern shoreline of Lake Albert is expanding into the lake due to siltation from River Semliki. From 1960 to 1980 it expanded 3.5 km and the same occurred from 1980 to 2000 it expanded 2 km into the lake. This has resulted in the expansion of the southern shoreline on to the land.

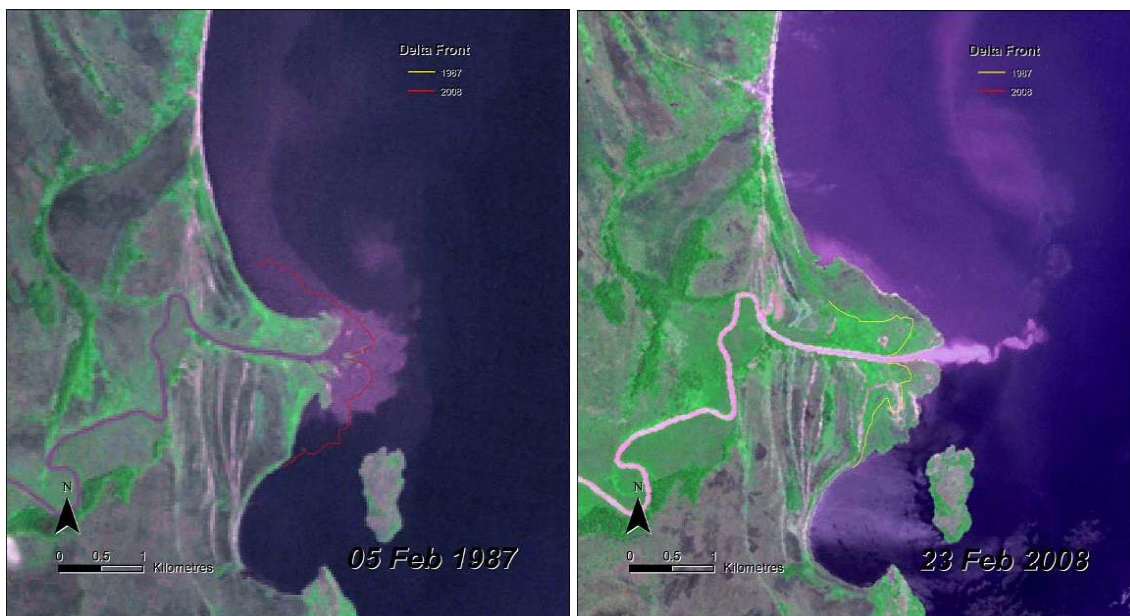
Figure 7: Silt from River Kagera enters Lake Victoria. The delta at the mouth of the river had increased in size by 2008 and it threatens to join with Musambwa island.

The Kagera River which originates from Burundi, forms the Rwanda-Tanzania, Tanzania-Uganda borders is the largest contributor of water from the catchments. The satellite images of 1987 and 2008 show high reflectance of water from the Kagera River due to silt. Silt and suspended solids impact on water bodies by loading nutrients into the lake. Nutrients stimulate algae growth which reduces oxygen leading to eutrophication and reduction in fish. Siltation is mostly associated with agricultural activities.

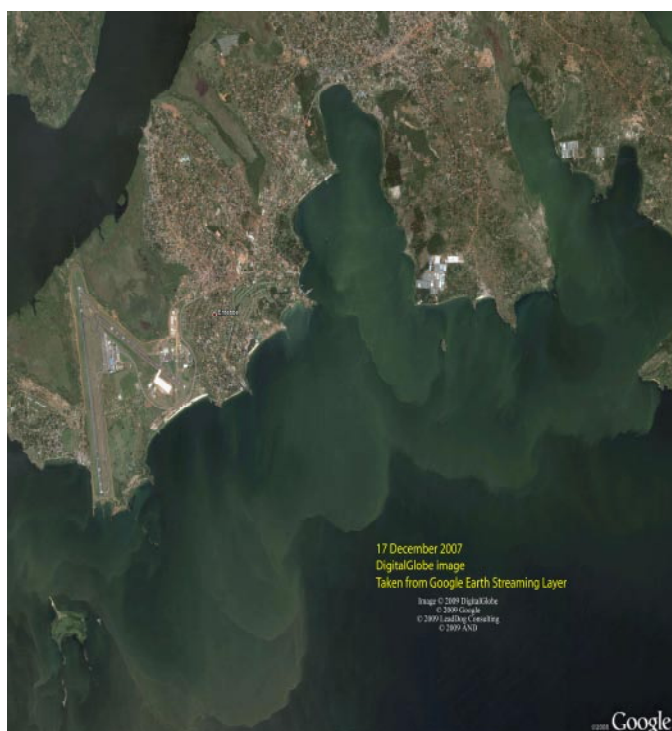
Figure 8: High turbidity on Lake Victoria on the 17th December 2007. The green substance is the algae bloom

Overtime the water in the Lake Victoria has become more turbid and this has a negative impact on the fish industry since it leads to silting up of the breeding grounds for fish. The algae mass, which looks like green oil paint on the lake surface, is a result of increased pollution from human disposal and industrial waste. This is an image shows Lake Victoria at Entebbe reflecting green colour.
